# Manhole Inspection Summary

Manhole # S43I\_\_038MH

Insp Date: **4/29/08 2:04 PM**

**Location** Address: **301 s broadway**

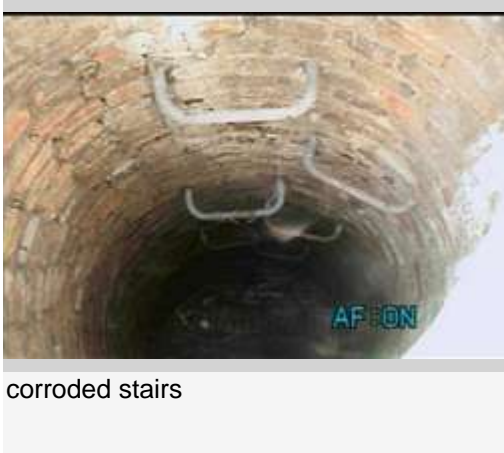
Miscellaneous

corroded stairs

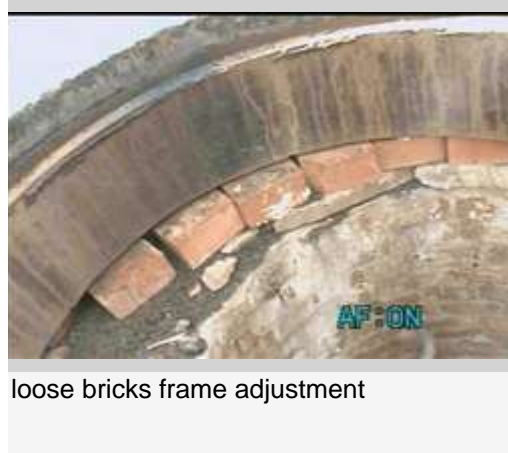
Defect 2

Condition: ☐ Sound ☐ Cracked ☐ Root Intrusion ☒ **Loose Brick** ☐ Deteriorated

loose bricks frame adjustment

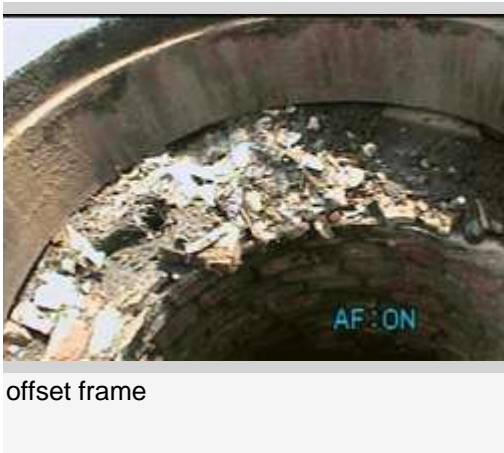
Defect 1

Offset: **9** (in.)

offset frame
